# University Tower Conservation and Restoration Works

# University Tower | Conservation and Restoration Works | 2012

MODAL IDENTIFICATION OF THE COIMBRA UNIVERSITY TOWER

EMPREITADA DE CONSERVAÇÃO  
E RESTAURO DA TORRE  
DA UNIVERSIDADE DE COIMBRA  
CONSERVATION AND RESTORATION  
OF THE UNIVERSITY TOWER

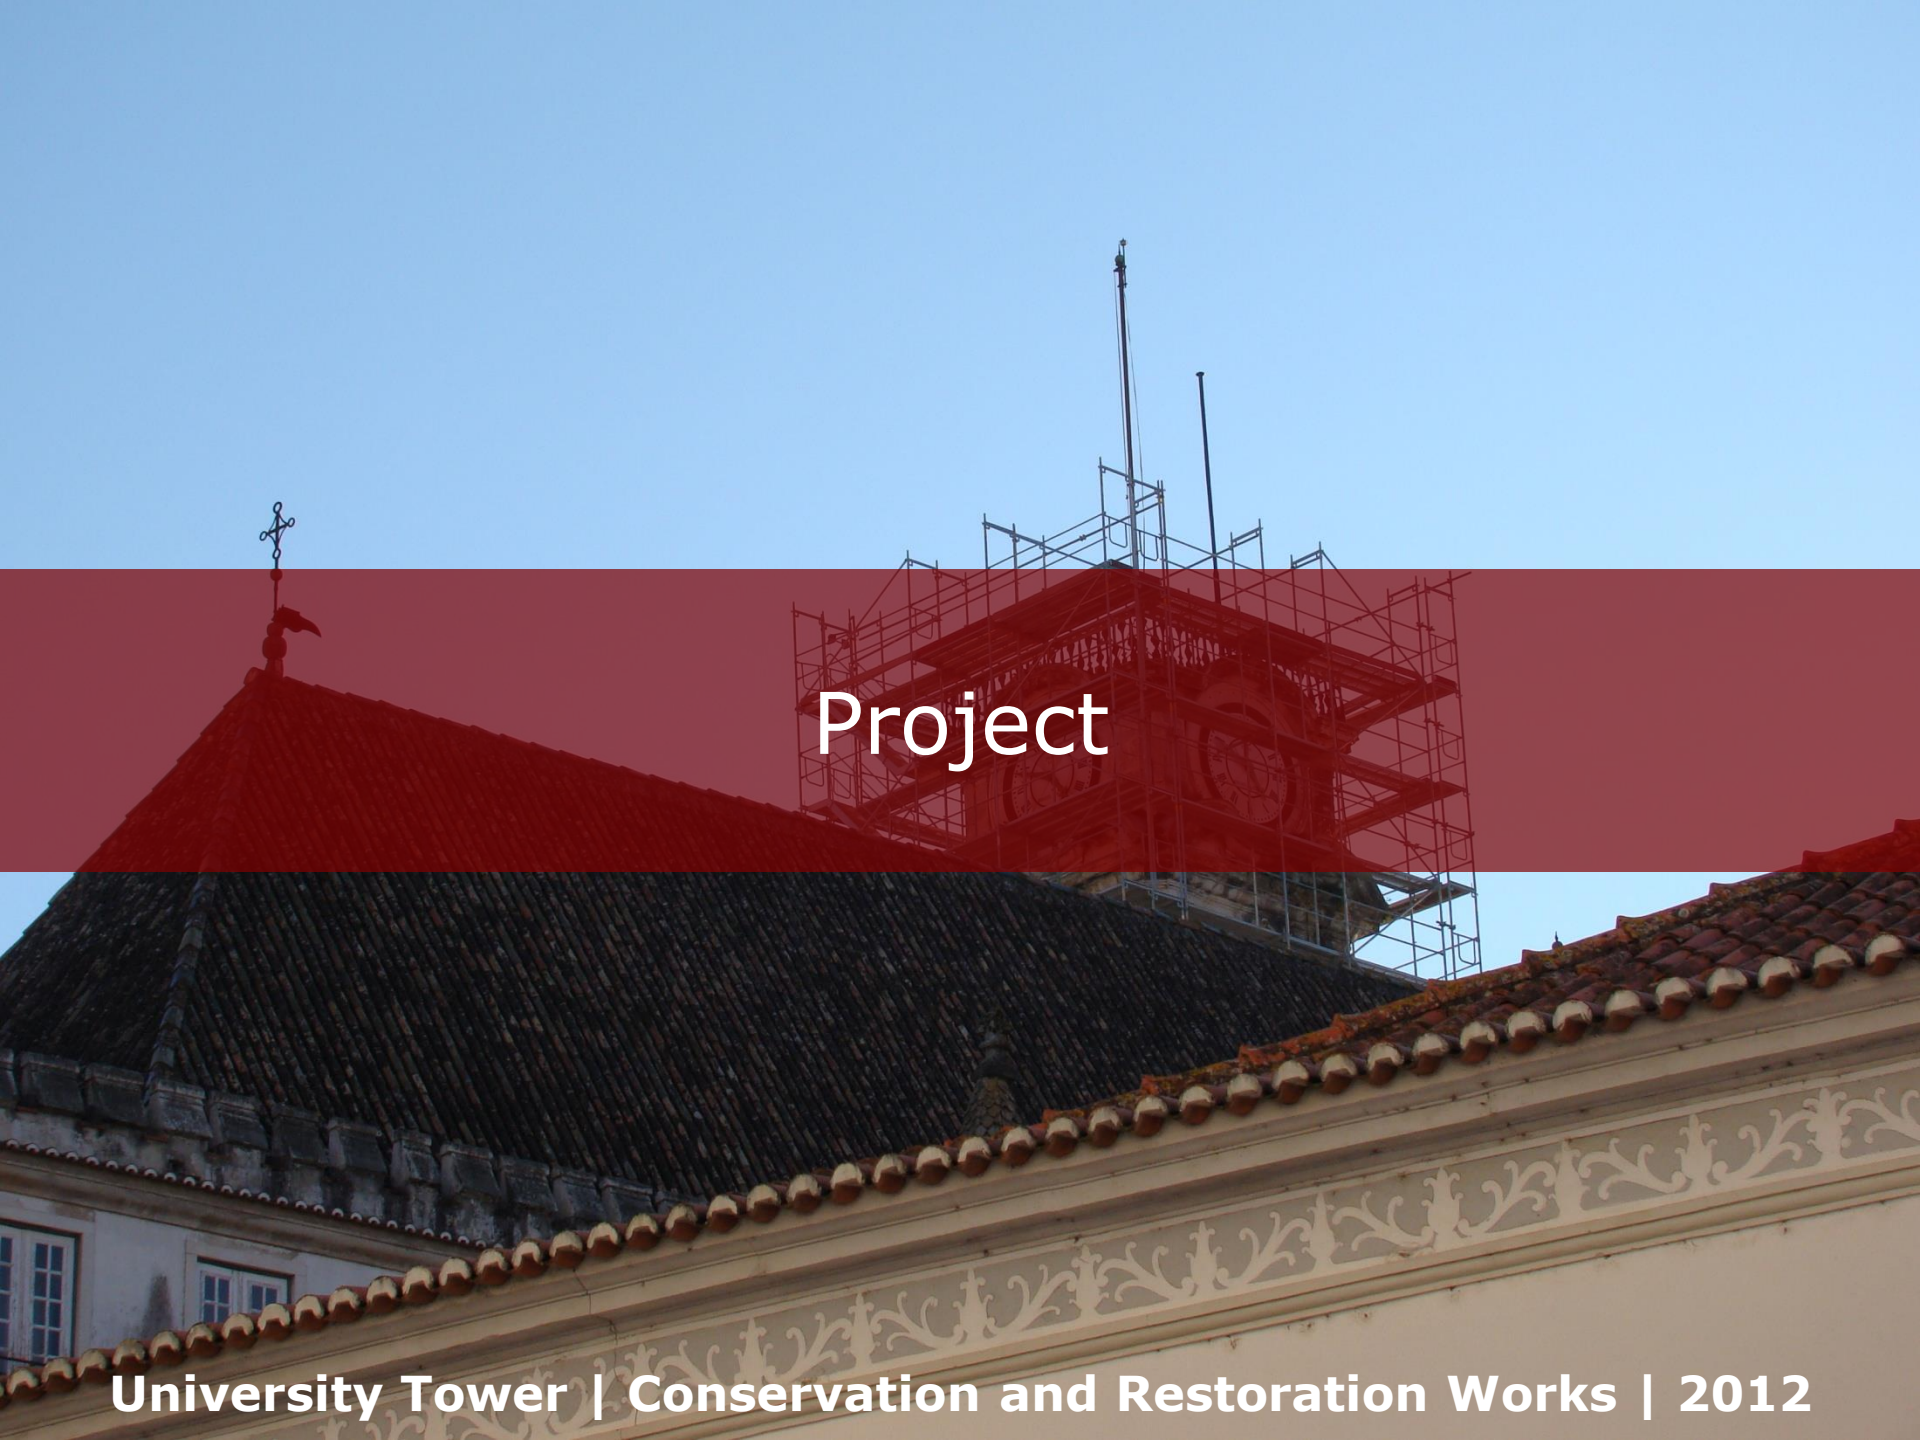
A photograph of the University Tower, a historic building with a dark tiled roof and a clock tower. The clock tower is surrounded by scaffolding, indicating restoration work. A red semi-transparent banner is overlaid across the middle of the image. The word "Project" is written in white text on the banner. The sky is clear blue.

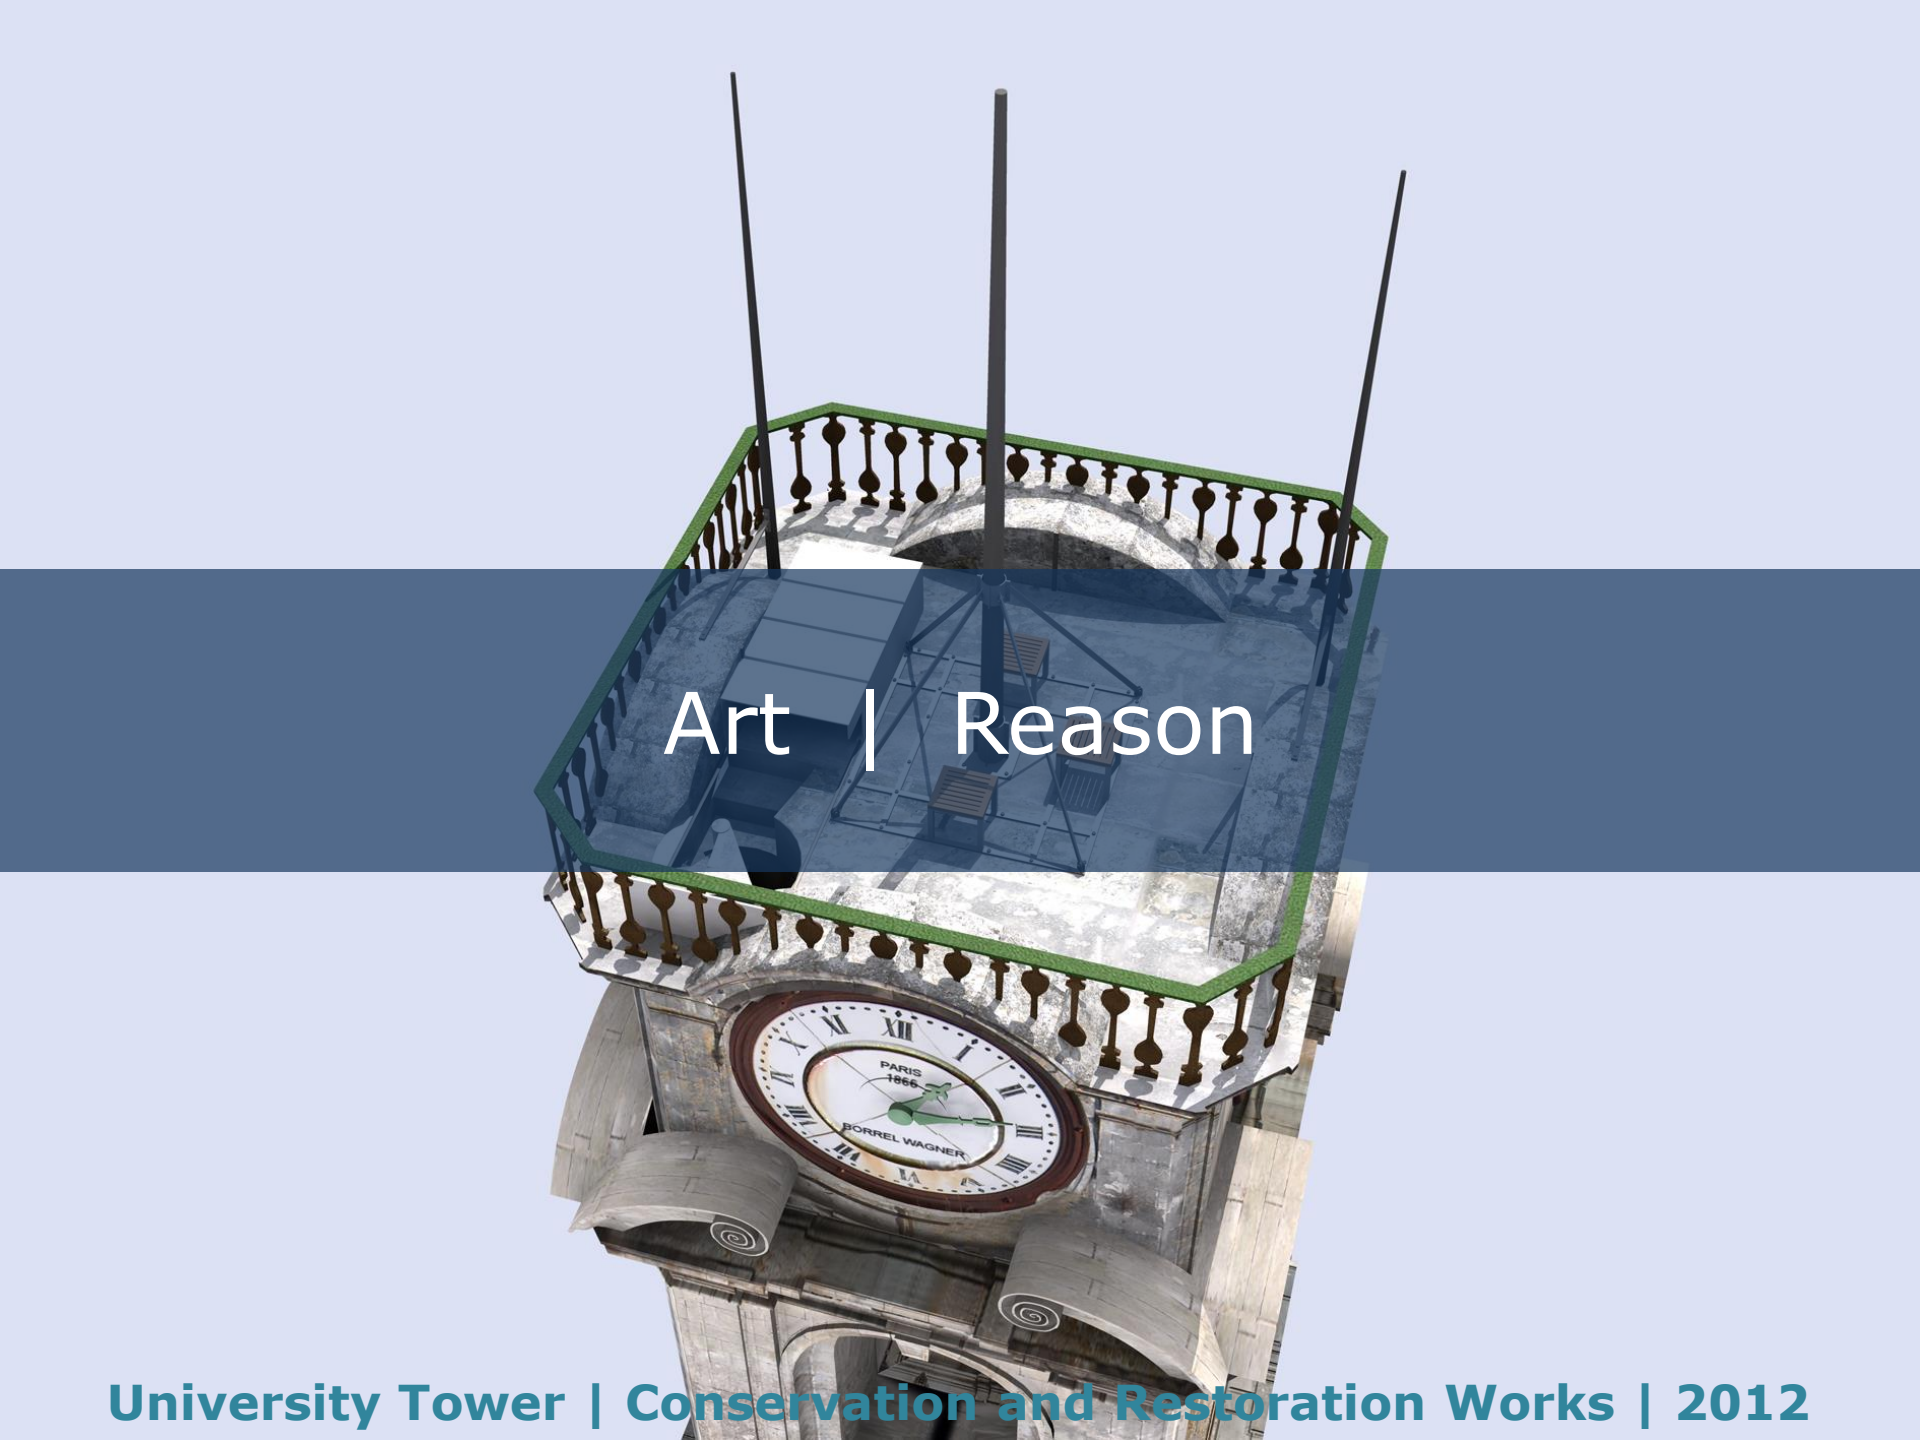
A 3D architectural rendering of the University Tower, showing the restoration work. The image is split horizontally: the top half shows the interior of the tower's upper section with a green-painted balcony and a central vertical shaft, while the bottom half shows the exterior of the tower with a large clock face. The text "Art | Reason" is overlaid in the center.

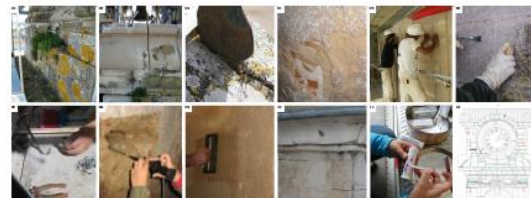
As imagens mostram as diferentes fases do trabalho de conservação e restauro da superfície pétrea da Torre. Desde a limpeza inicial até à aplicação dos materiais de conservação.

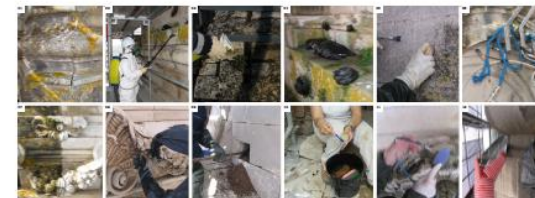
As imagens mostram as diferentes fases do trabalho de conservação e restauro da superfície pétrea da Torre. Desde a limpeza inicial até à aplicação dos materiais de conservação.

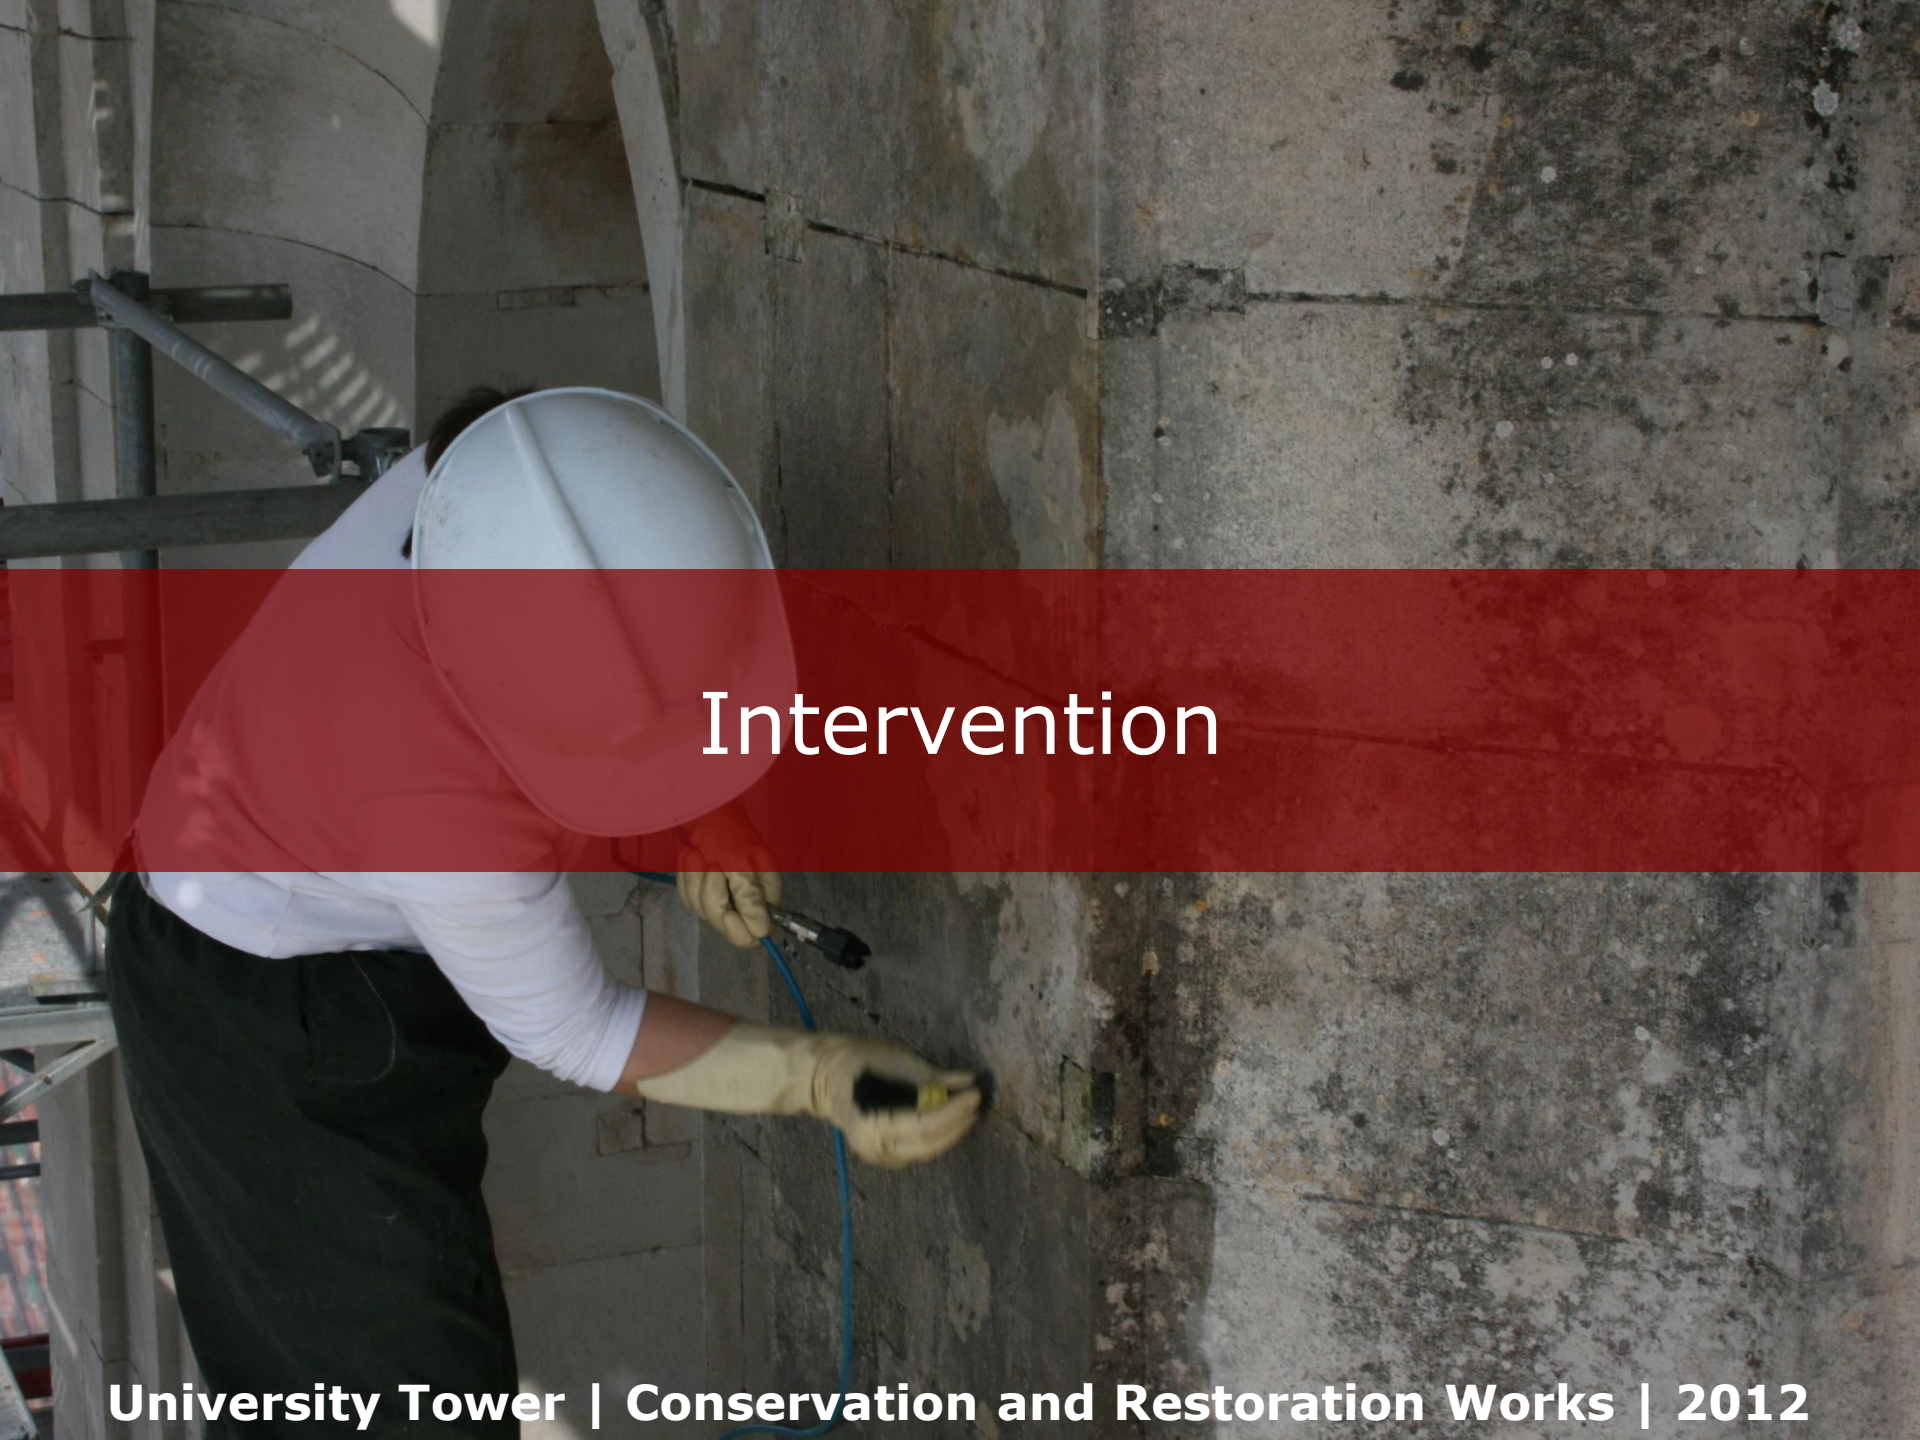
A photograph of a worker in a white hard hat and yellow gloves using a blue hose to clean a stone wall. The worker is wearing a white long-sleeved shirt and dark pants. The background is a large, textured stone wall with visible joints and some staining. A red horizontal band is overlaid across the middle of the image.

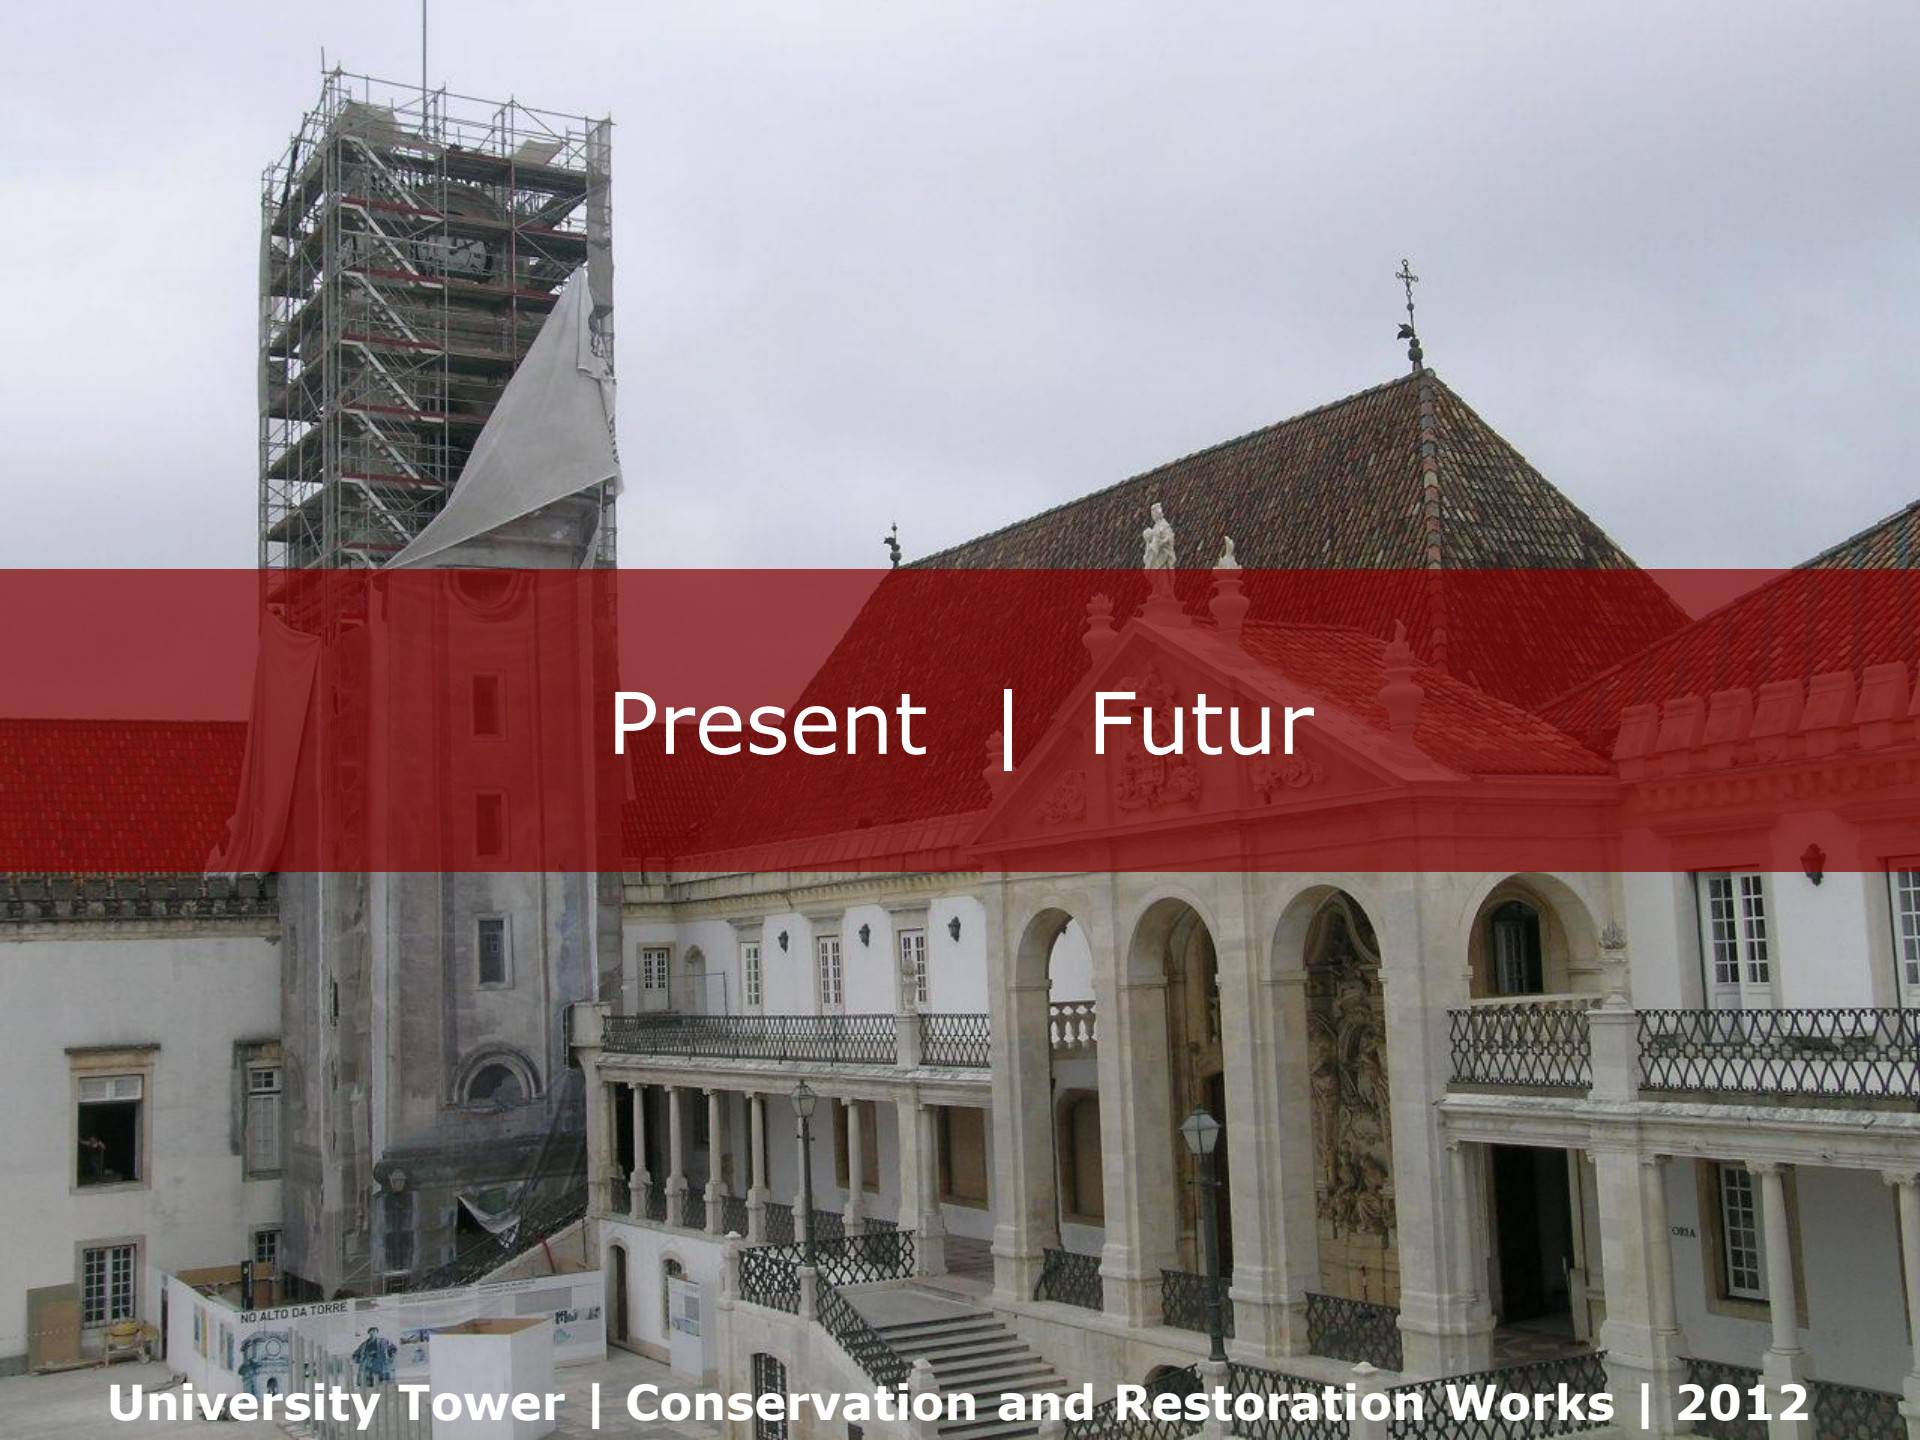
The image is a composite of two photographs. The top half shows the University Tower, a tall, narrow stone structure, completely encased in a complex network of metal scaffolding. A large white sheet is draped over the right side of the tower. The bottom half shows a courtyard of the University of Coimbra, featuring a two-story building with a series of arches on the ground floor and a balcony with a decorative wrought-iron railing on the upper floor. A set of stairs leads up to the balcony. A red semi-transparent banner is overlaid across the middle of the image, containing the text 'Present | Futur'.
